BU-3025/BU-3025v2/BU-2015 shows no image in CoreNVR split screen?

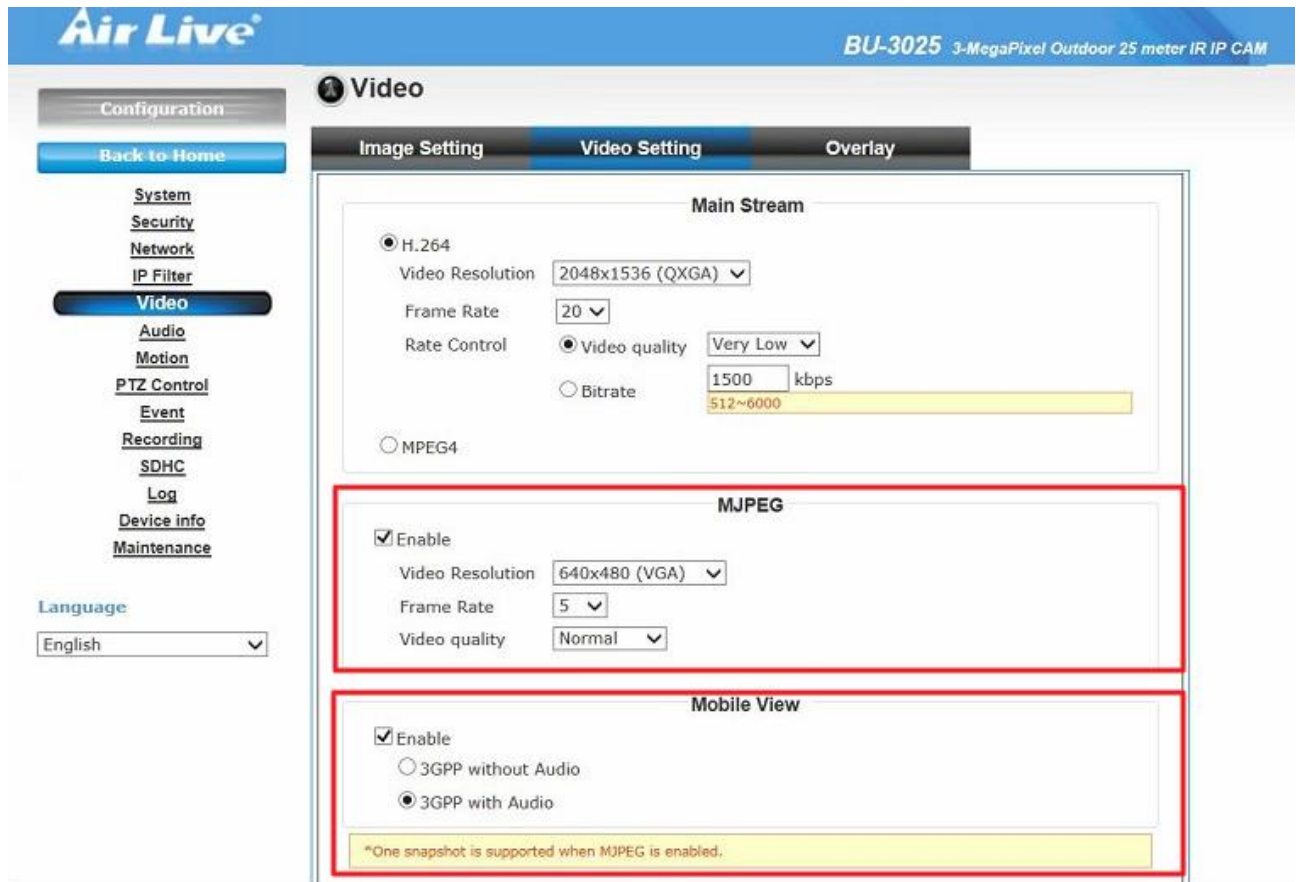
1. Please make sure **CoreNVR 9/16** F/W version is above **2.0.0.1384**.
2. Please make sure **BU-3025** F/W version is **1.03.13**.
3. Please make sure **BU-3025v2** F/W version is **1.03.18**.
4. Please make sure **BU-2015** F/W version is **1.03.18**.
5. Enable the “**MJPEG**” & “**Mobile view**” in BU-3025/BU-3025v2/BU-2015.
